***IN-SITU TESTS OF THREE
BENTS AT SOUTH TEMPLE
BRIDGE ON INTERSTATE 15 –
FINAL REPORT***

**Civil & Environmental
Engineering Department
University of Utah
Salt Lake City, Utah**

**Utah Department of Transportation
Research Division**

June 2003

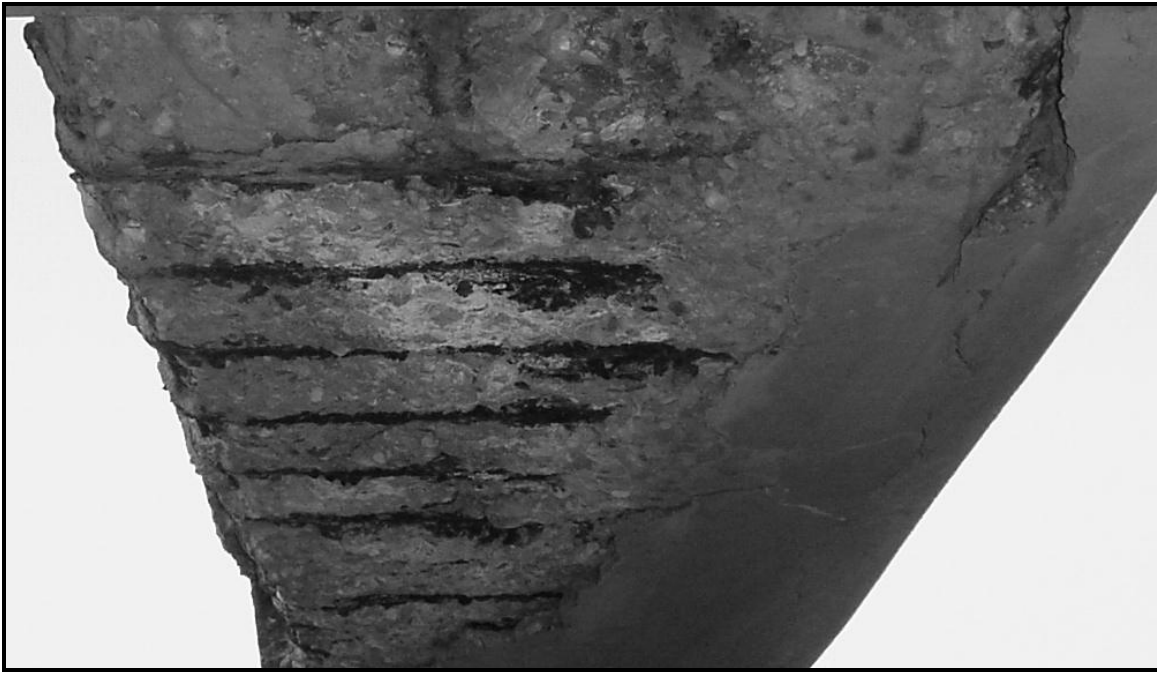
The general condition of Bent #4S in the spring of 2000 was as follows: the vertical columns had very minor cracking and hardly any spalling, and the horizontal cap beam had practically lost its clear cover. There had been severe spalling on various sections of the 37 year old structure due to concrete degradation brought on by rebar corrosion/expansion and freeze/thaw action. Although the significant spalling appeared to be restricted to the cap beam on the bottom face between the columns and the three vertical faces of both tapered ends, the entire cap beam vertical faces had many hollow sounding spots that rendered the clear cover of the cap beam useless. These areas of the cap beam also revealed longitudinal and transverse reinforcement that had been severely weathered. The columns, strut-beams and pile caps were all clean and intact. Photographs of spalling are provided in Figures 2.5, 2.6, and 2.7. Clearly, the state of the cap beam was in serious deterioration; more details for an in-depth study of the impact of the corrosion on the shear capacity can be found in the study for the northbound bridge tests carried out in 1998 (Pantelides et al. 2000).

Figure 2.5 Spalling under cap beam of Bent #4S

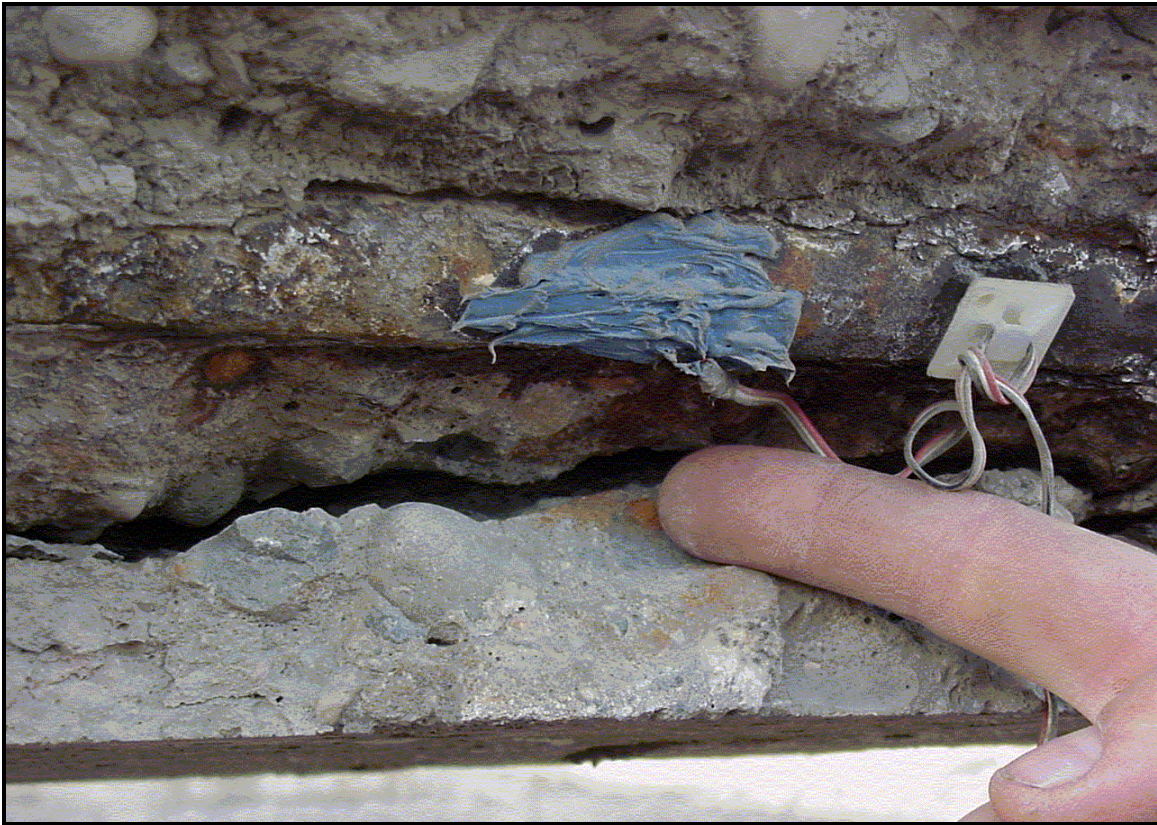
Figure 2.7 Clear cover under cap beam barely attached on Bent #4S

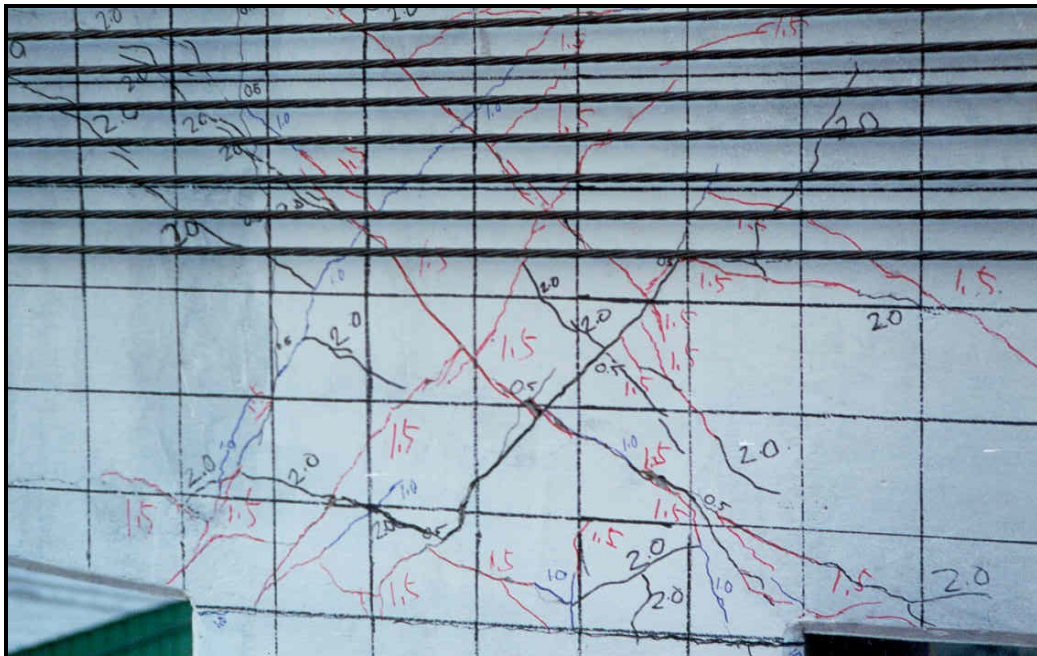
Figure 2.48 West column-bent cap joint at 2% drift ratio

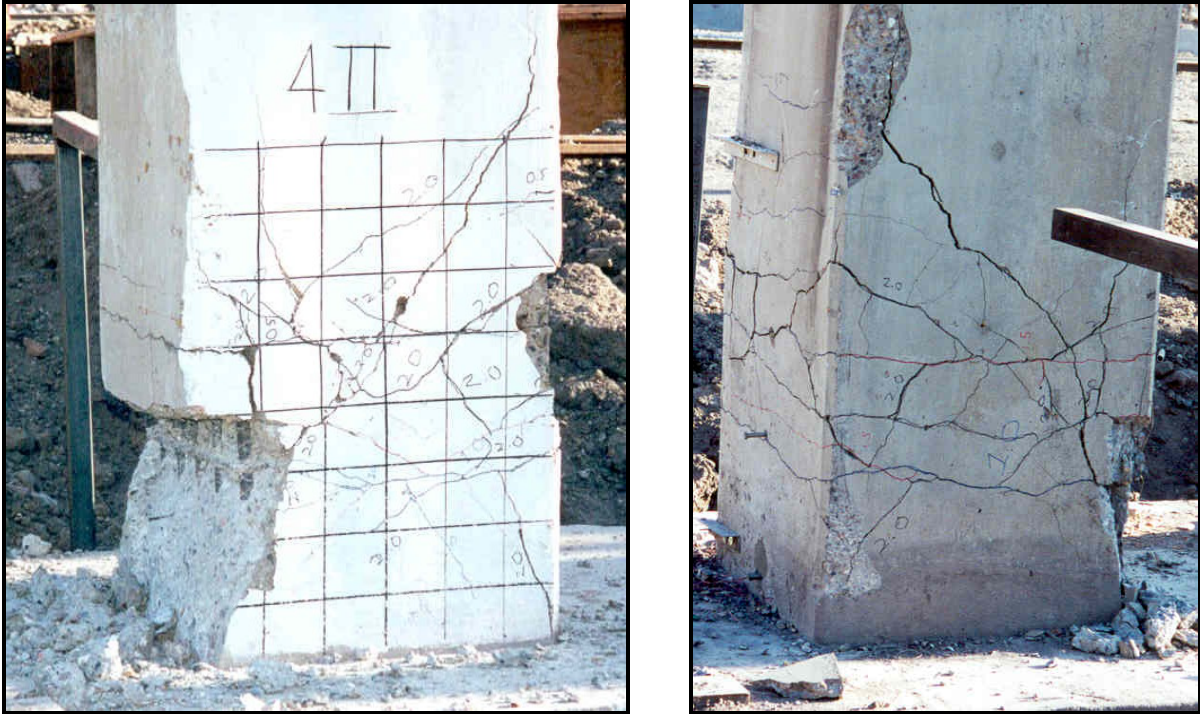
Figure 2.60 Center column base at 5% drift: (a) West side and Southwest corner showing buckled bars, (b) North face

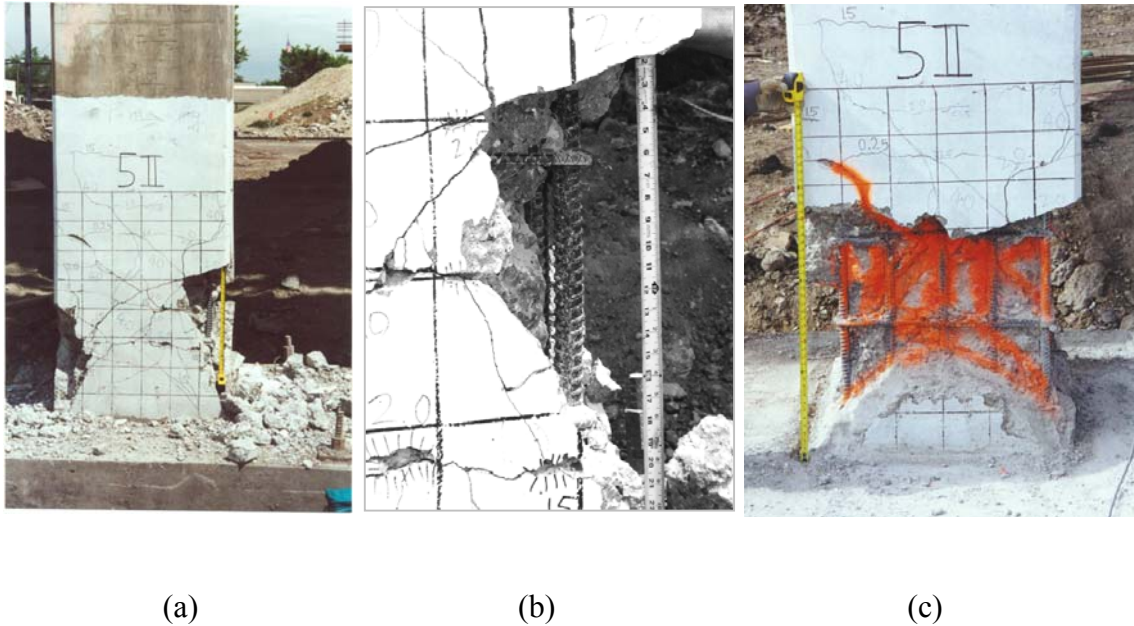
Figure 3.17 Damage to Bent #5S (2000) lap splice at bottom of center column: (a) after test, (b) detail showing buckled column bar, (c) lap splice after post-test investigation

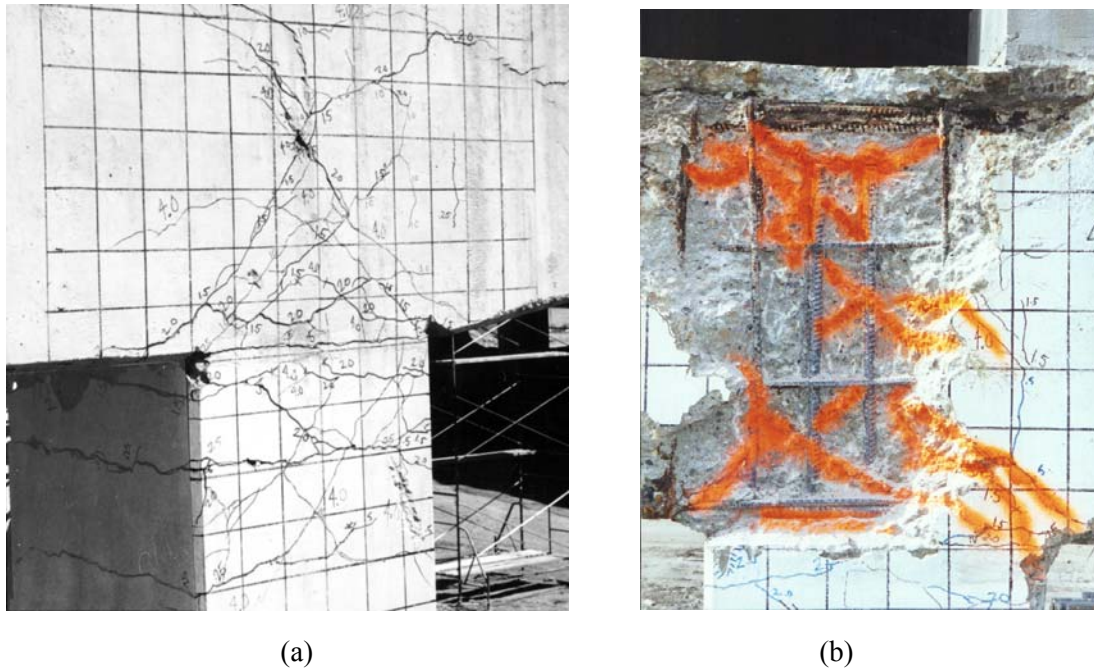
Figure 3.21 Damage to bent cap-column joints of Bent #5S (2000): (a) center column joint at end of test, (b) east column joint after post-test investigation

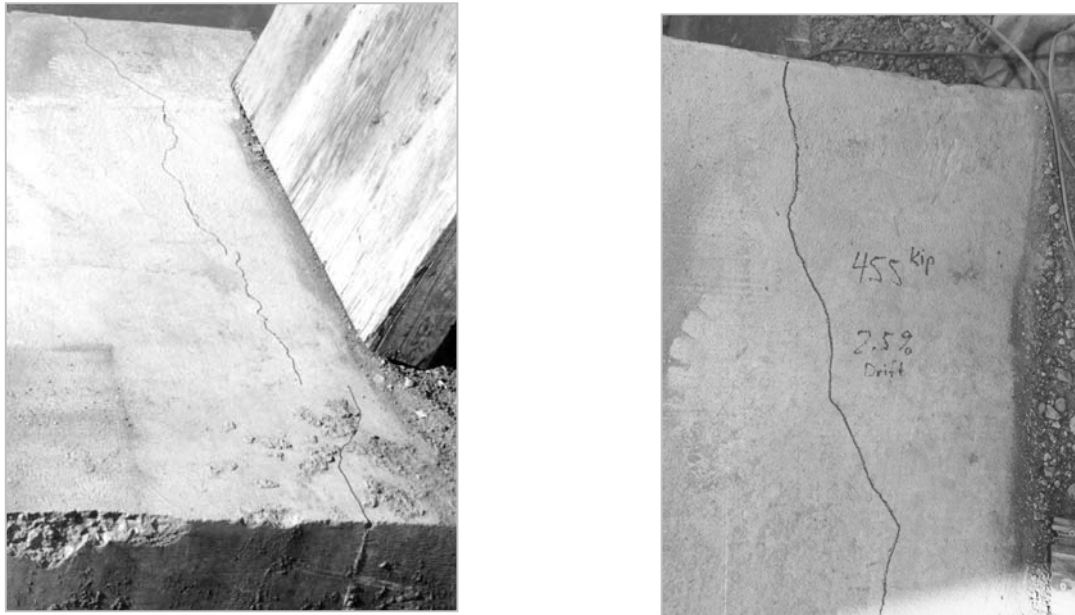
Figure 3.22 Cracks in the grade beam at a drift ratio of 2.5%: (a) center pile cap, (b) close up on the top of the grade beam

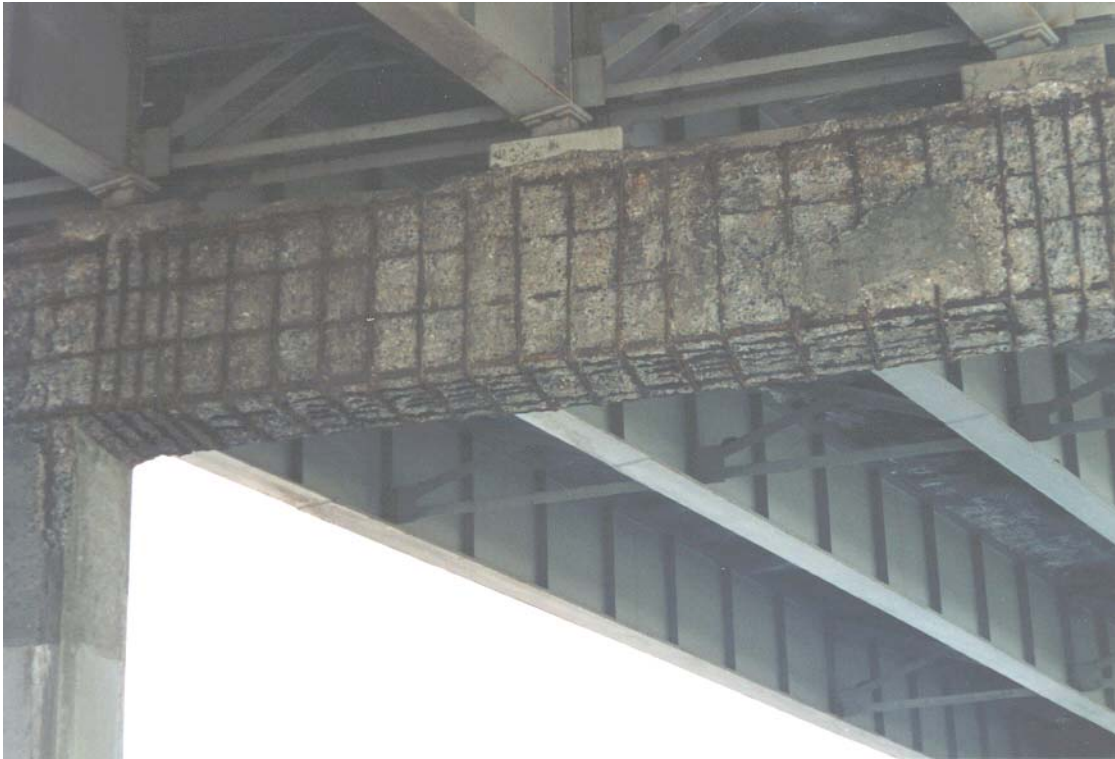
Figure 4.6 Loose cover concrete removed from Bent #6S showing cover concrete delamination and loss in vertical stirrup area in the bent cap

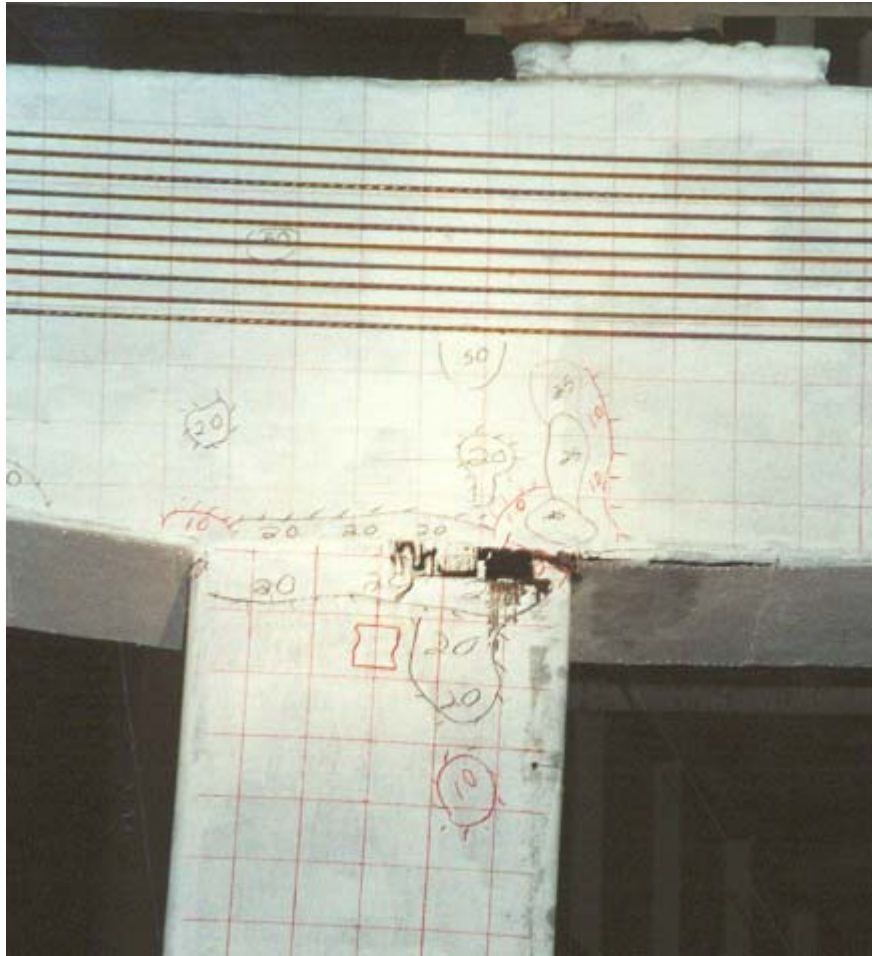
Figure 4.85 U-strap failure shown at 4.0% drift step

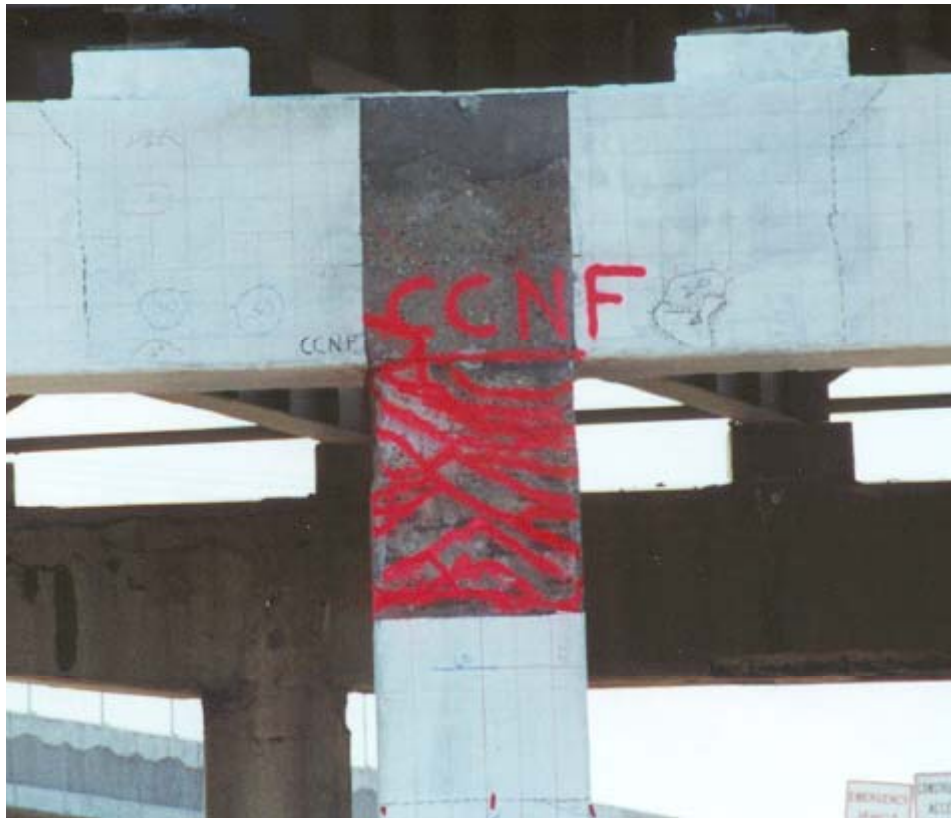
Figure 4.90 No column reinforcement steel pullout and no damage sustained on the cap beam portion of the Middle column

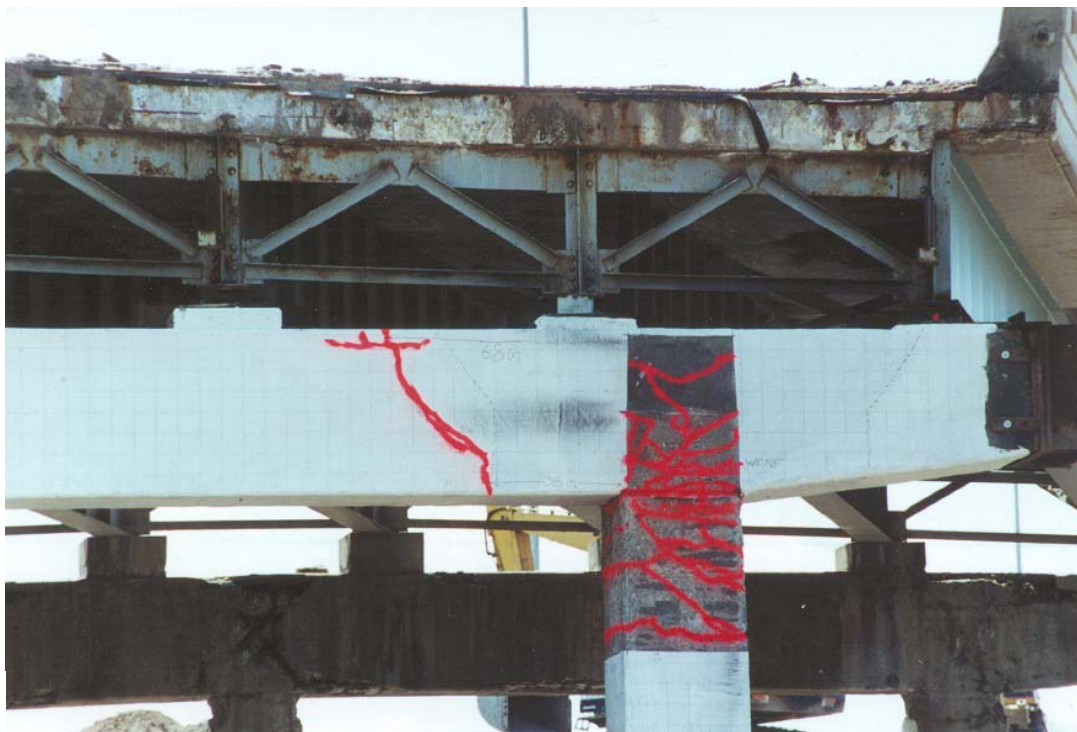
Figure 4.112 Cap beam reinforced by road deck diaphragm system preventing complete failure
